M. Ida Converse Building

15 Ferry Street

Preliminary Conditions Review
In Support of
Potential Building Move

April 2021

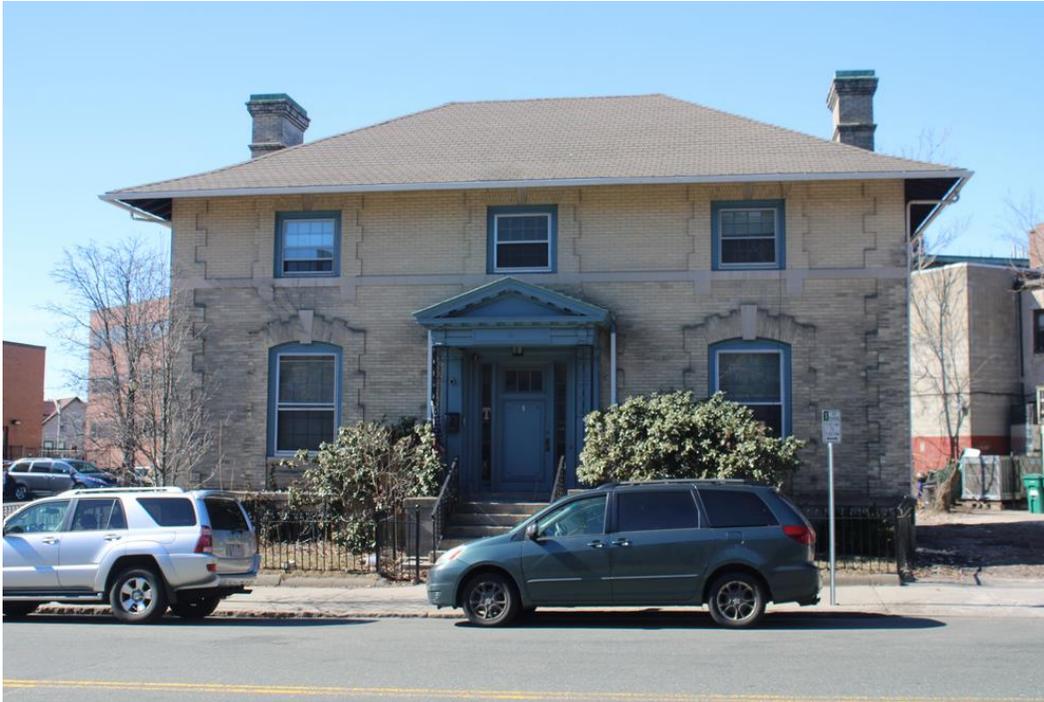
Image 1 East elevation. Note brick treatment around windows and at corners as well as extensive soiling at the corners and below the second-floor level.

The brick appears to be in good condition but is very dirty with atmospheric and biologic soiling. The pattern of the most significant soiling at the corners and below the second floor suggests that some of this soiling is due to foundation plantings. The southwest corner of the building is covered with ivy from the ground up to the eaves which may conceal more serious conditions.

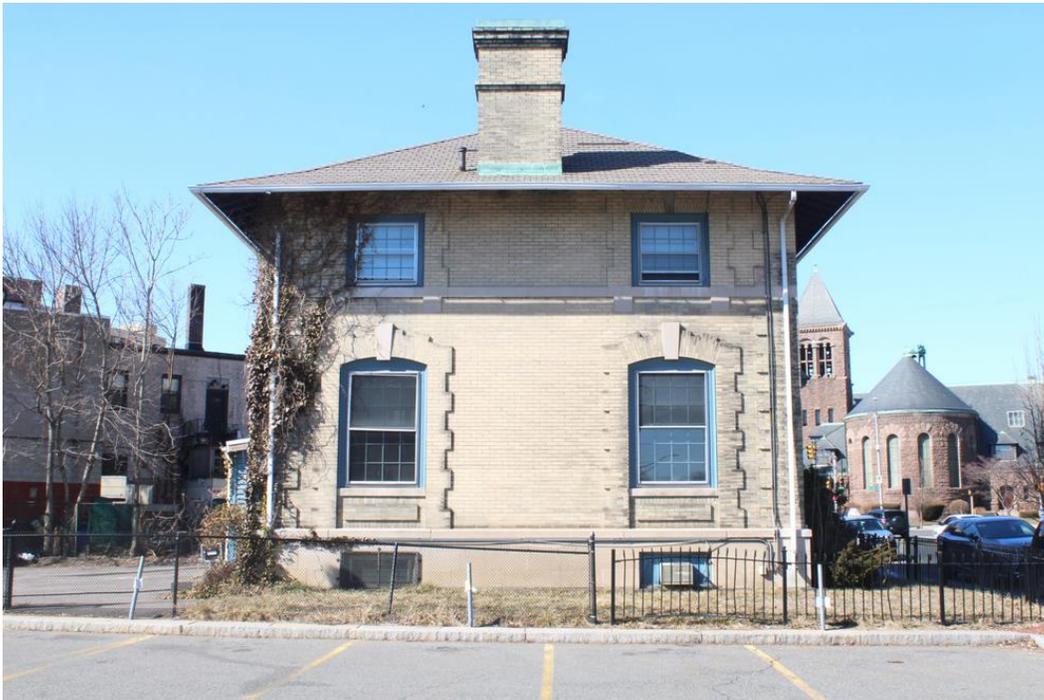
Image 2 South elevation showing ivy climbing southwest corner of building.

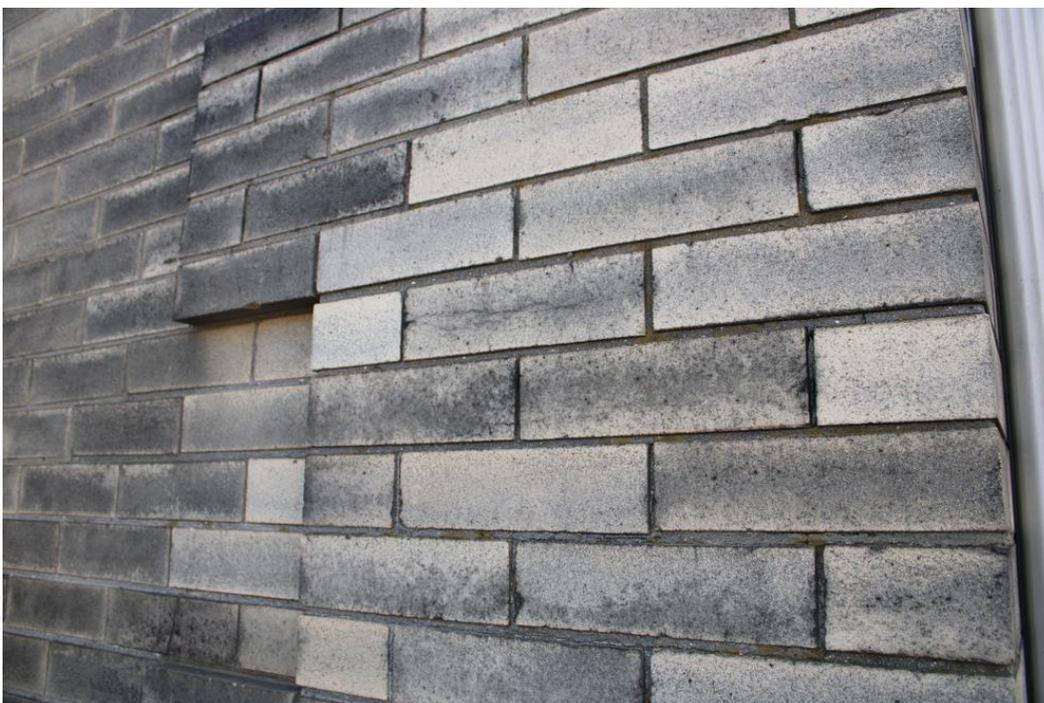
The narrow, recessed mortar joints are largely intact with random areas of minor mortar loss, primary at the lower levels.

Image 3 Typical brick conditions showing heavily stained bricks, narrow, recessed mortar joints.

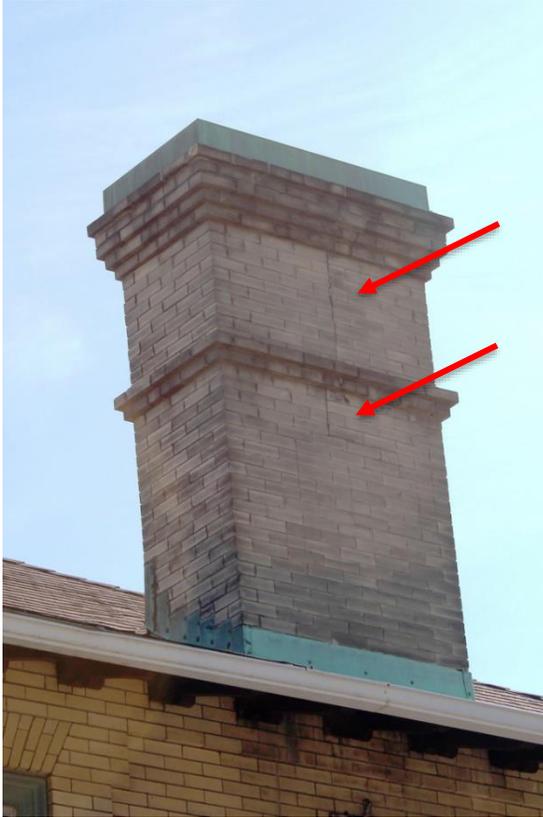
Deferred maintenance at the north chimney has led to large cracks which will require extra attention and stabilization prior to the building move. Repairs to this crack are recommended after the successful move. Post-relocation treatments are also recommended to address deferred maintenance with respect to the masonry. These treatments include repointing of the brick and limestone and cleaning all masonry surfaces to remove the atmospheric and biologic soiling. At the interior, deferred maintenance at the second floor stair hall will also require additional monitoring and stabilization efforts prior to the move.

The chimney at the north end exhibits a large crack running from the top corbelling, through approximately 10 courses, the corbeled drip course, and finally stopping approximately 4 courses below the drip course. Additional courses of brick are also cracked to the right and left of this centered crack. The rear face of the chimney was not visible during this assessment. The chimney at the south of the building exhibits some cracking through a few courses just below the drip course.

Image 4 Extensive cracking at north chimney

Extra attention should be spent in stabilizing the chimney during the building move process.

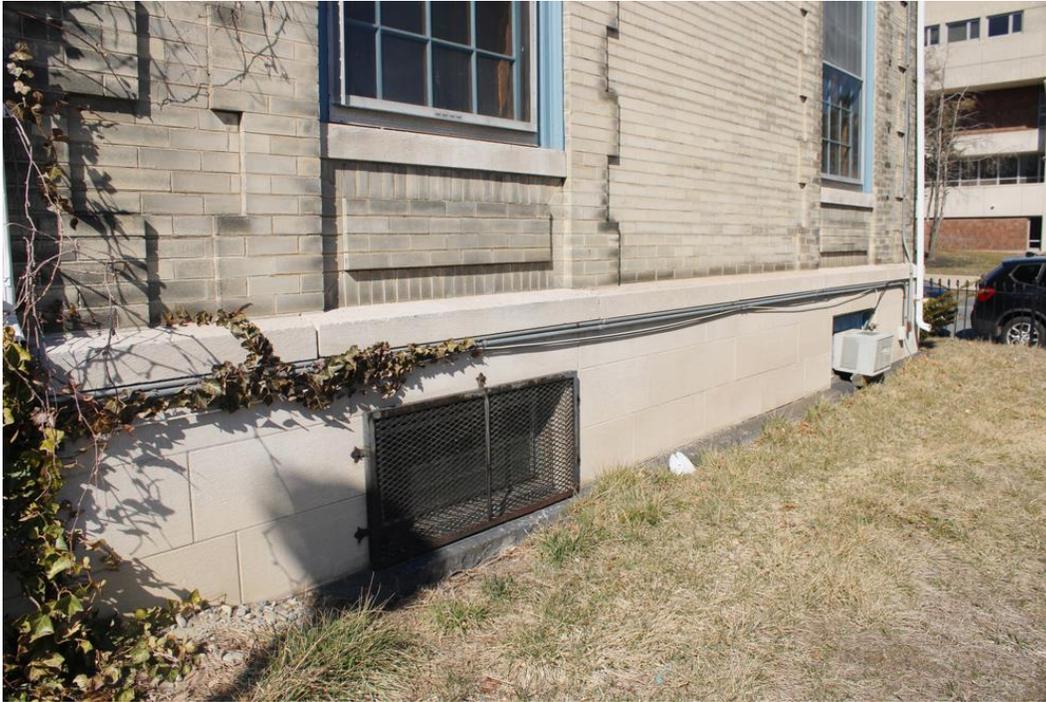
The building has an exposed ashlar limestone foundation with a limestone water table. There is mortar loss close to ground level and some areas of the limestone exhibit some exfoliation. As the interior basement is finished, it is not known if the limestone is veneer or structural. A section of exposed brick is located at the south elevation which suggests that the limestone – and the brick at that location – are veneer over a (possibly) concrete foundation.

Image 5 South elevation showing limestone foundation with limestone water table.

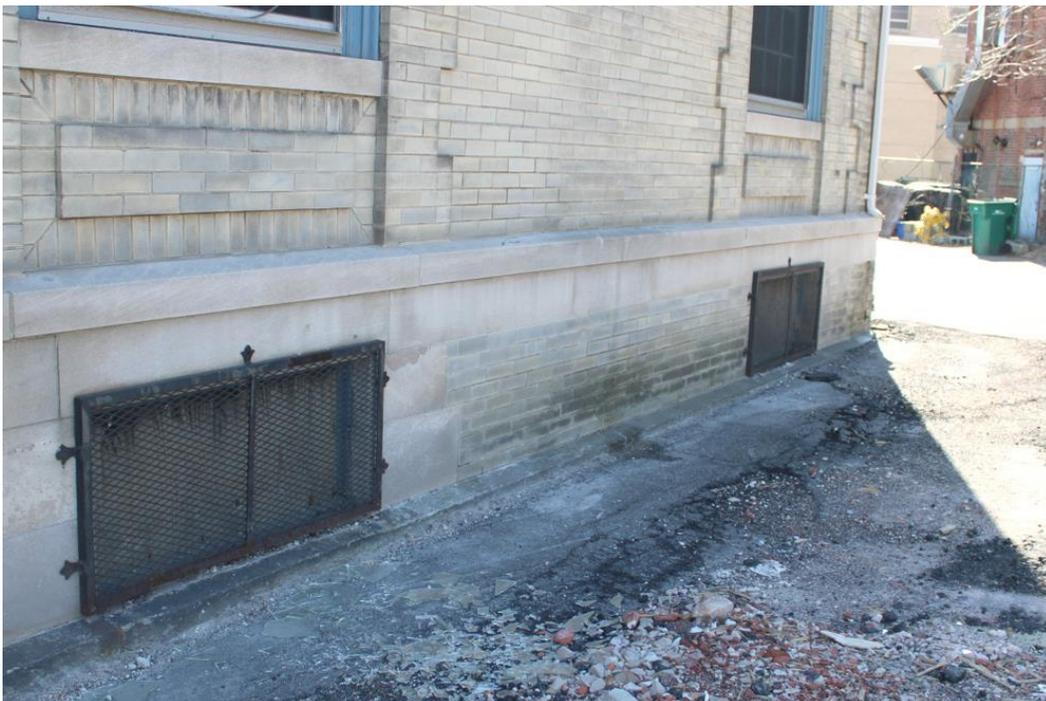
Image 6 North elevation showing brick at west side of foundation.

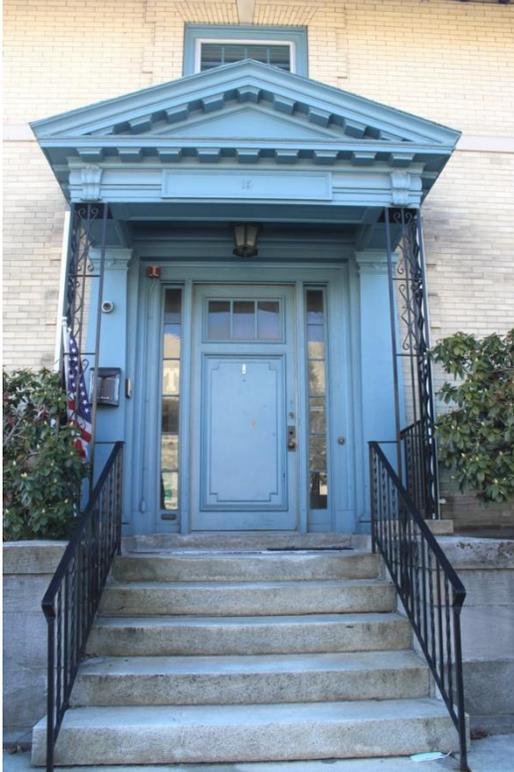
The portico at the front entrance is accessed from a run of five granite steps and features original wood detail elements such as the pilasters, pediment, and side lites. The front entrance door may also be original. This entrance retains an original letter slot below the left side lite and the original light fixture, originally fueled by natural gas. The original wood columns were reportedly replaced during the 1970s by the steel supports.

Image 7 Front entrance and portico. Iron supports are not original. All other elements including the postal slot and the light fixture appear to be original.

It is anticipated that moving the building will require removal of the front entrance portico, the rear shed addition and the limestone foundation elements. Full restoration of the portico and foundation elements is anticipated following a successful move. Replicating the original wood columns at the portico is recommended. The rear shed addition is not original to the building but may offer an important storage area not otherwise available. If this addition is restored or rebuilt, it should not be enlarged beyond its existing footprint and height.

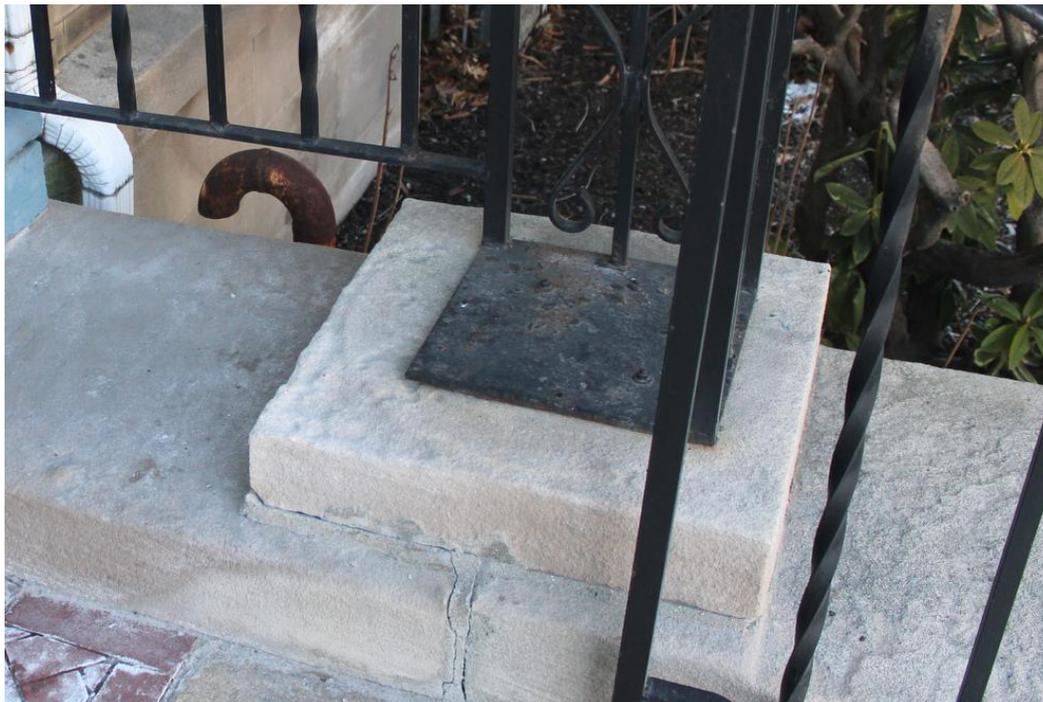
Image 11 Circular outline of original wood column, granite base at front portico.

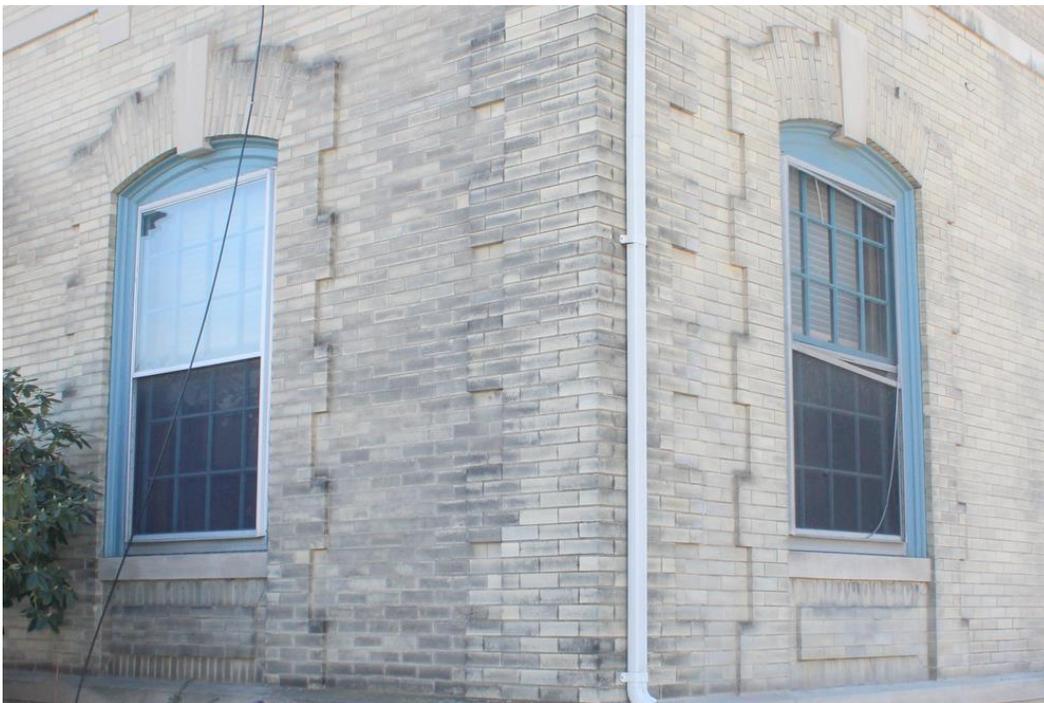
The exterior aluminum storm windows are in fair condition, with significant damage at one window on the north elevation. These storm windows are not original, but they have helped protect the original sash. Given the condition of the exterior storm windows and associated screens, replacement of these storm windows following a building move is recommended. Where they are intact, they may provide an additional level of protection during the anticipated building move.

Image 12 First floor windows, northeast corner. Window at right has damaged exterior storm window.

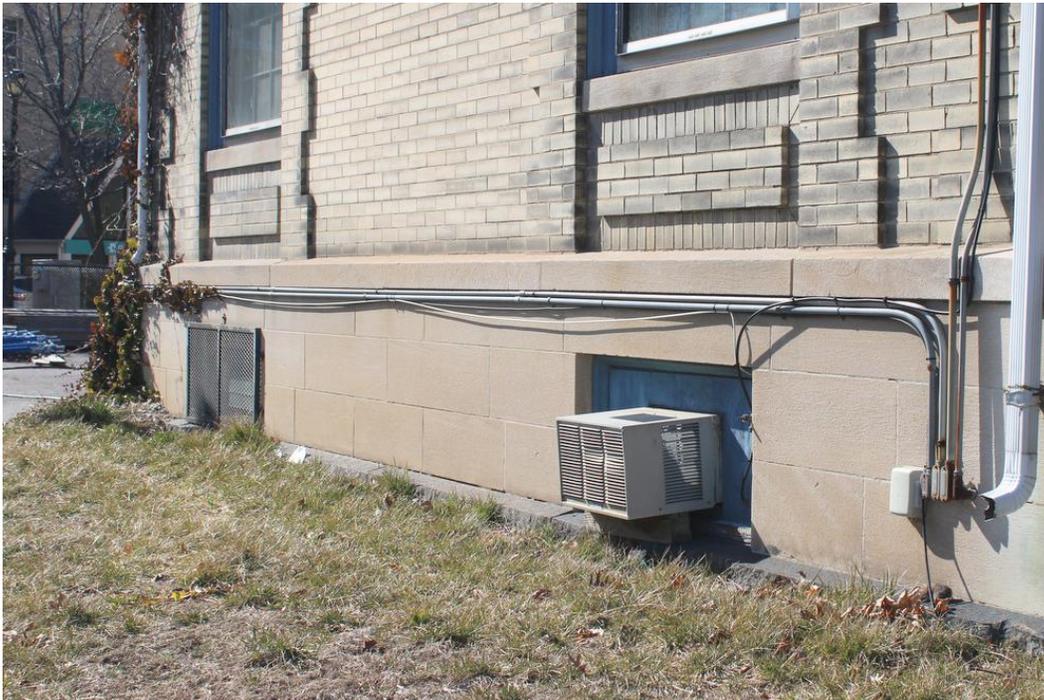
At the basement level, window openings (two per elevation) have either been covered over or have been fitted with window air conditioning units. Where there is not an air conditioning unit, these basement windows retain original metal grillwork secured to the limestone foundation.

Image 13 Basement window openings showing either original metal grille work or modern air conditioning unit fit into plywood opening.

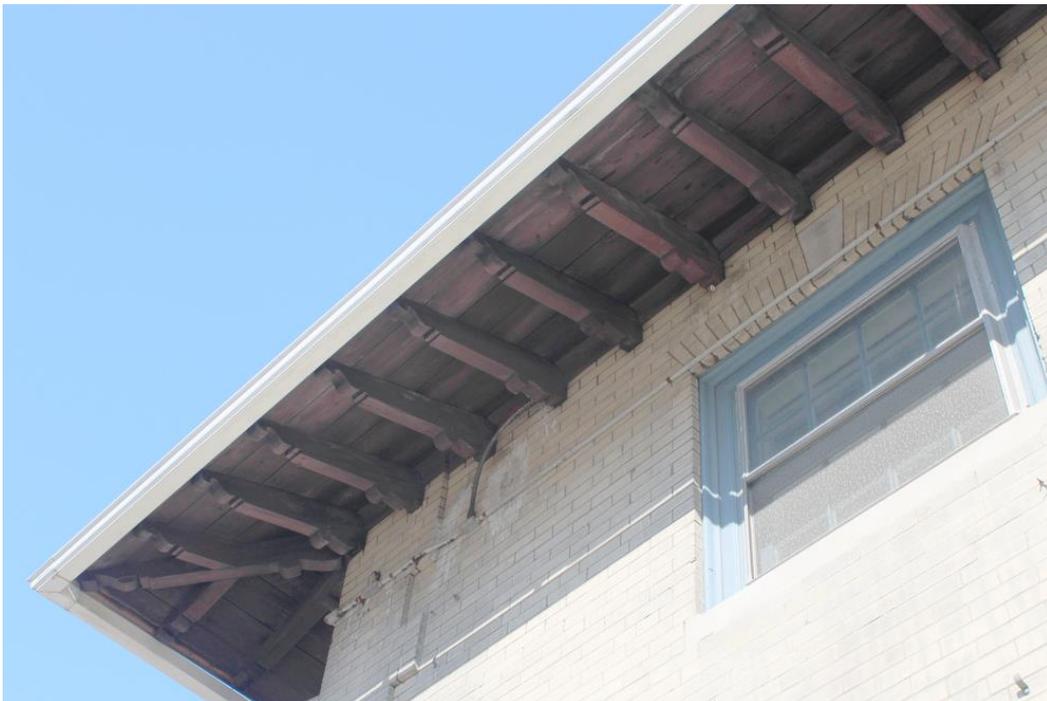
The building's roof is clad in asphalt shingle and includes a shingled cricket located at the base of each chimney. The date of the current asphalt roof installation is unknown; however, it does appear to be in good condition. The deep projecting cornice features wood rafter tails. These rafter tails appear to have been stained in the past. While this element is largely protected from the weather, the stain coating appears to be weathering off.

Image 15 View of roof overhang showing original rafter tails.

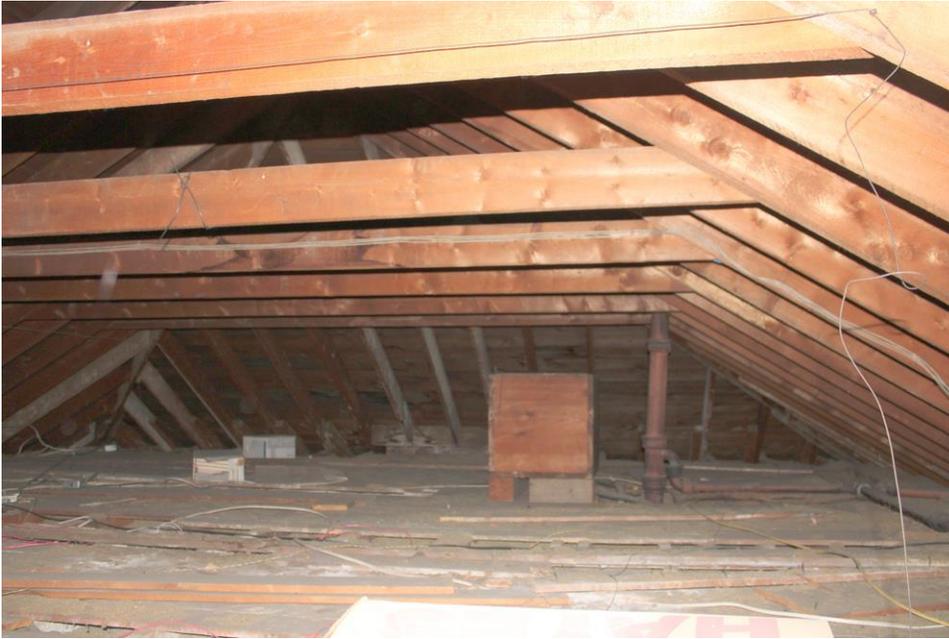
Image 23 View in attic, looking south. Note original wood cistern at this location.

Access to the attic space is gained through a ceiling hatch in a small room adjacent to the stairway. The attic reveals that the framing is dimensional wood lumber. The attic floor space is at least partially filled with cellulose insulation. The chimneys are not visible in the attic space due to the pitch of the roof and the location of the chimneys at the eaves. An original wood cistern is located towards the south end of the attic. It should be confirmed that the cistern is empty before moving the building.

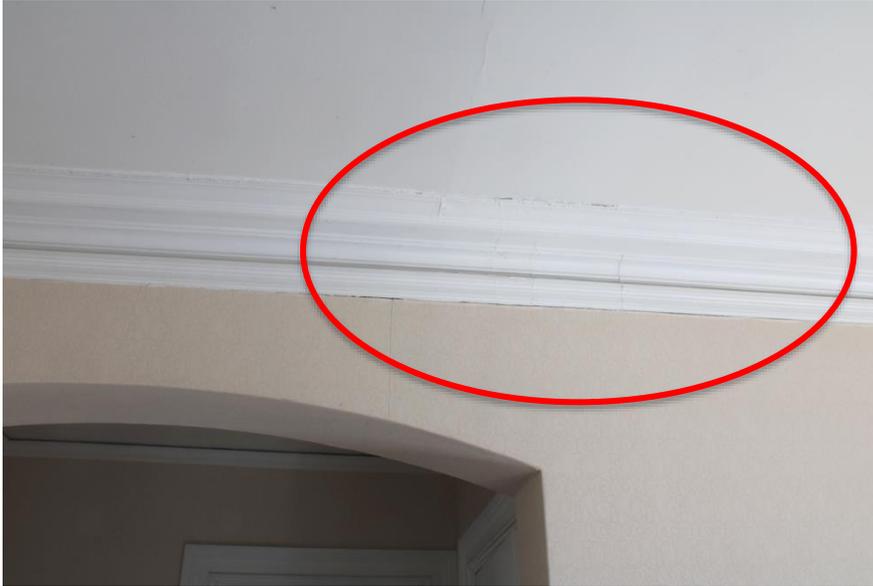
The cornice at the second-floor stair hall warrants extra attention and stabilization prior to the move. The cornice in the locations pictured shows evidence of possible leaking and deferred maintenance. The locations are directly across from each other at the top of the stairway. While there are other instances of plaster cracking of ceilings that may reflect overlading of the second-floor office spaces (bookshelves, files, etc.) over time, these two areas stand out for the irregularity of finish.

Image 27 View of cornice, second floor stair hall, looking south. Note cracking and irregularity of finish at this location. Same condition is observed at opposite end of stair hall.

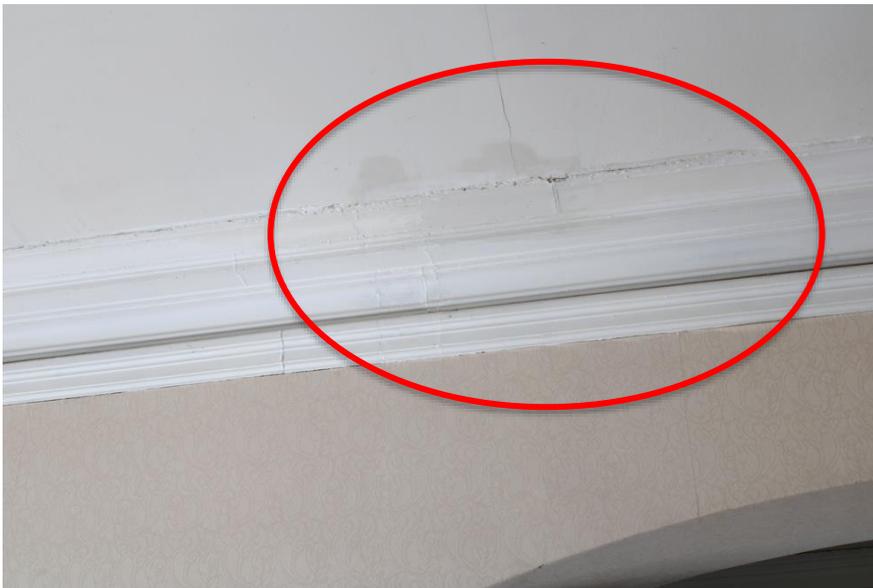
Image 28 View of cornice, second floor stair hall, looking north. Note cracking and irregularity of finish at this location. Same condition is observed at opposite end of stair hall.

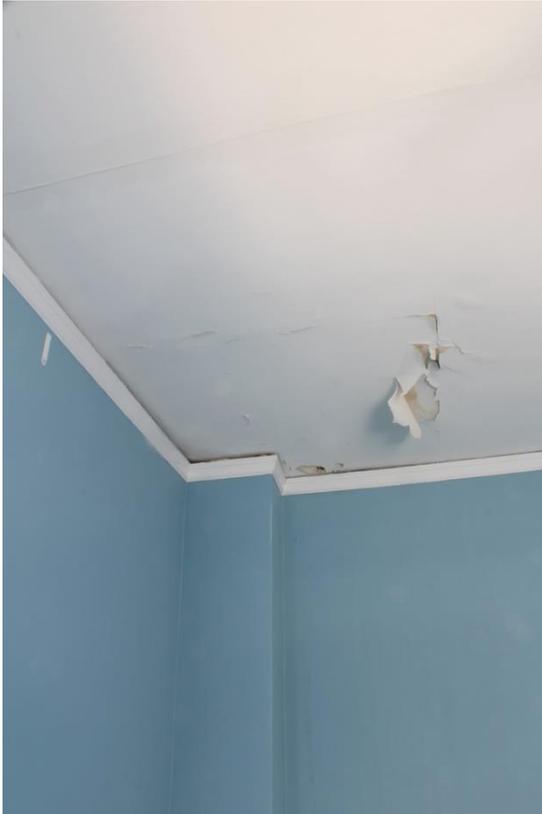
Image 29 Water damage in ceiling of northwest room, below chimney with large crack.

As noted in the exterior section of this report, there is a large crack in the north chimney. In the second-floor rooms below this chimney, there is obvious evidence of water damage due to water infiltration through that chimney crack. After the building is successfully relocated and the chimney repaired, the interior finishes should be restored.

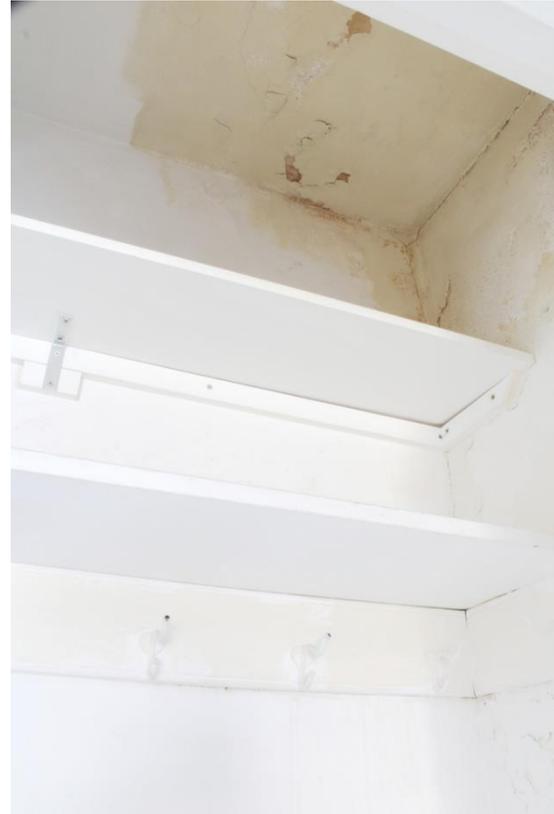
Image 30 Water damage in ceiling of closet of northeast room, below chimney with large crack.
