M. Ida Converse Building

15 Ferry Street

Preliminary Conditions Review
In Support of
Potential Building Move

April 2021

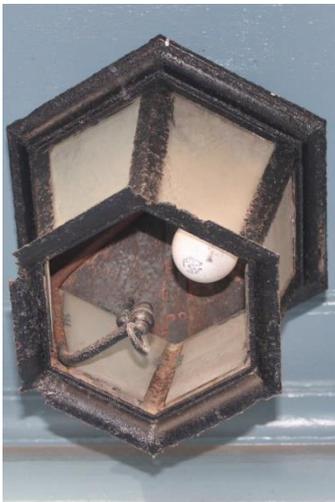
Image 8 Original light fixture in front entrance portico. Fixture has been electrified, but original gas mantle is extant.

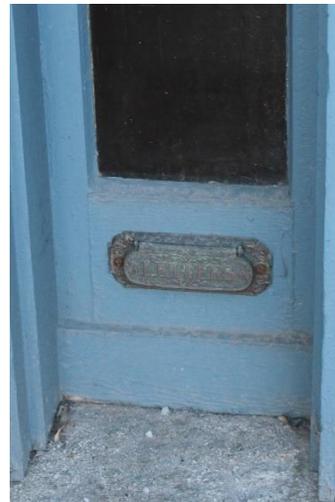
Image 9 Original letter slot below left sidelite at front entrance.

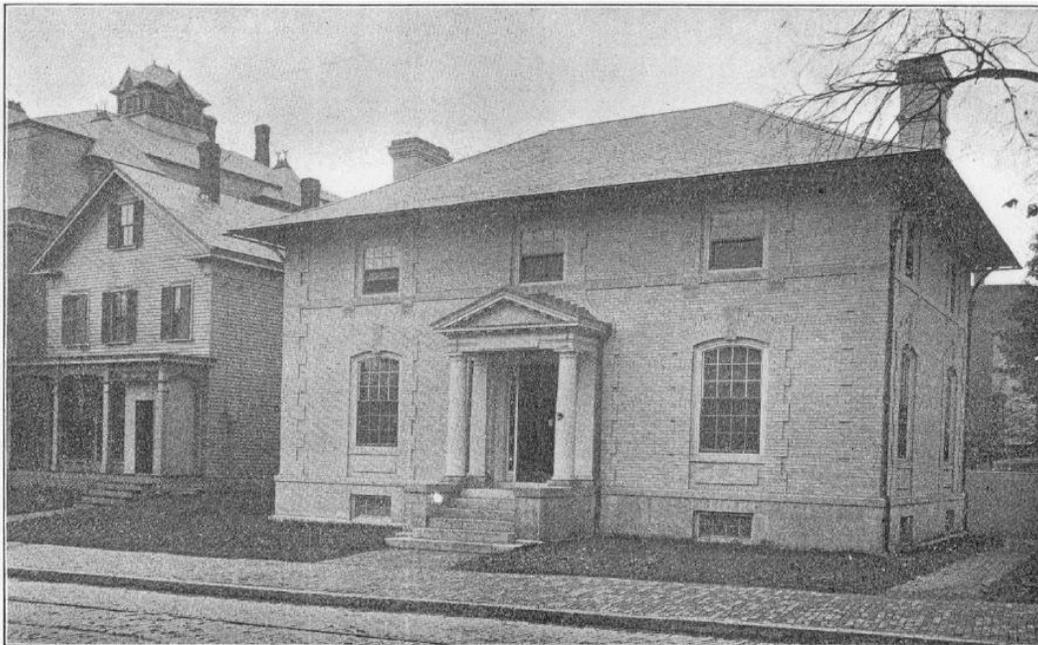
Image 10 Circa 1906 image showing 15 Ferry Street building with wood columns at the entrance portico.
image source: *Massachusetts Historical Commission Form B, MAL.491, 2019.*

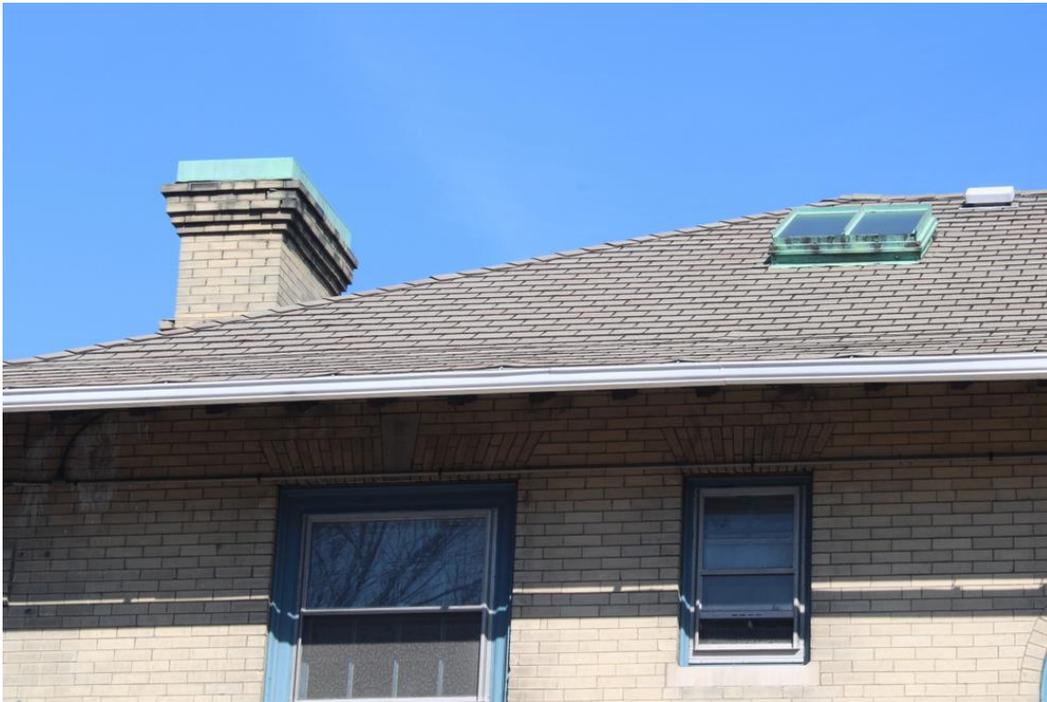
The building's roof is clad in asphalt shingle and includes a shingled cricket located at the base of each chimney. The date of the current asphalt roof installation is unknown; however, it does appear to be in good condition. The deep projecting cornice features wood rafter tails. These rafter tails appear to have been stained in the past. While this element is largely protected from the weather, the stain coating appears to be weathering off.

Image 14 View of roof showing asphalt shingles and original skylight for attic space.

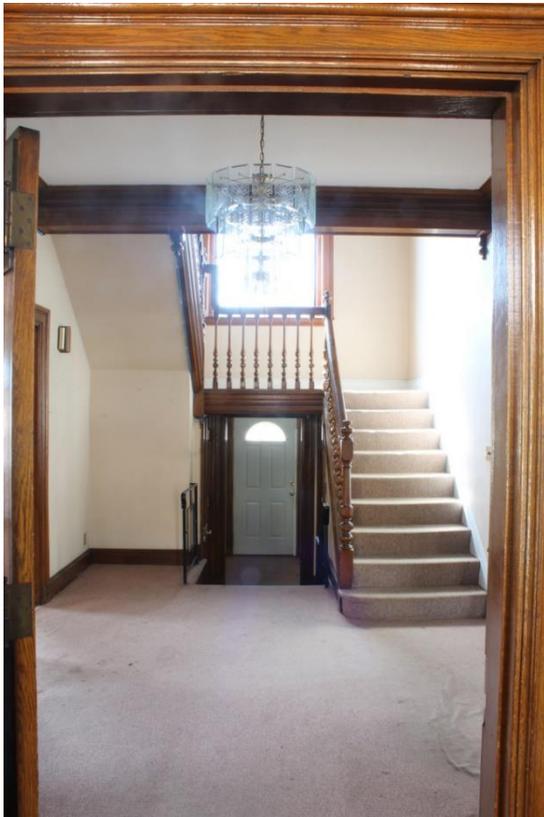
Image 16 View of first floor stair hall from entrance vestibule. All woodwork and spatial configuration are original. Far door is located in shed addition at rear of building (not original).

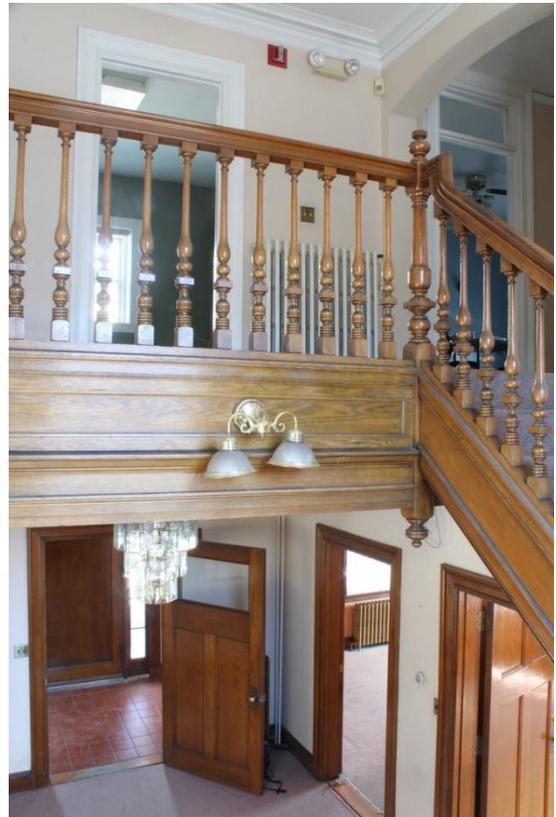
Image 17 View from stair hall landing. Note original transom over second floor door at right.

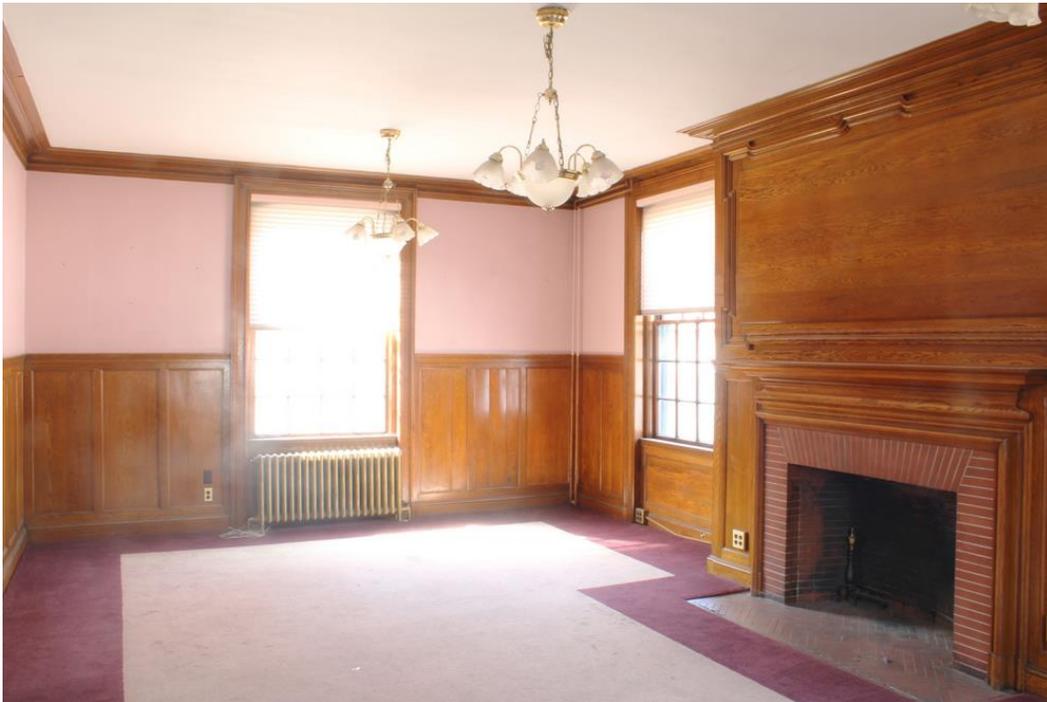
Image 18 Principal first floor room as seen from entrance vestibule looking northwest. Original wood wainscot, fireplace surround, baseboard and cornice.

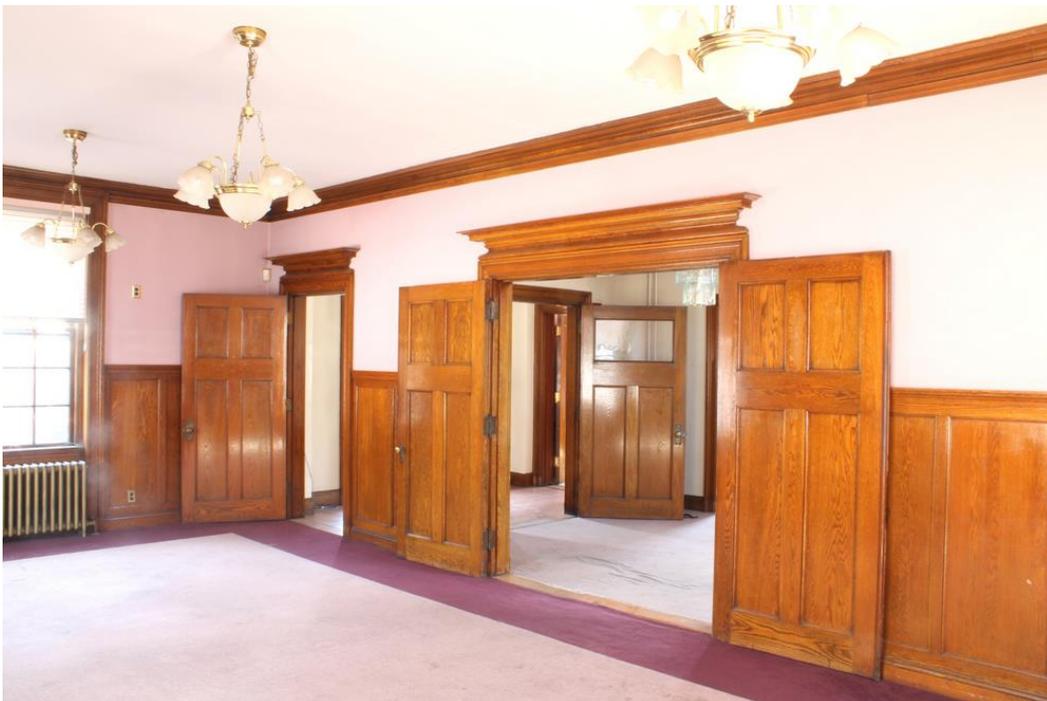
Image 19 Principal first floor room as seen looking toward entrance vestibule looking southeast. Original wood wainscot, doors and associated surround, baseboard and cornice.

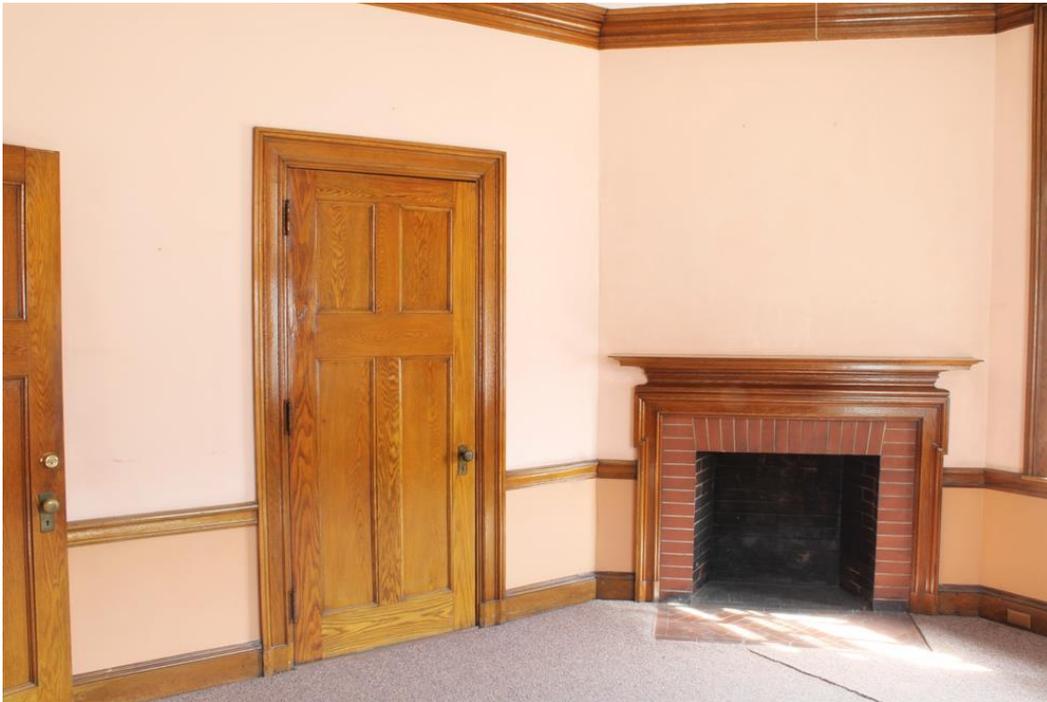
Image 20 Smaller first floor room at southwest corner. Room retains original wood doors and trim, chair rail, baseboard and cornice.

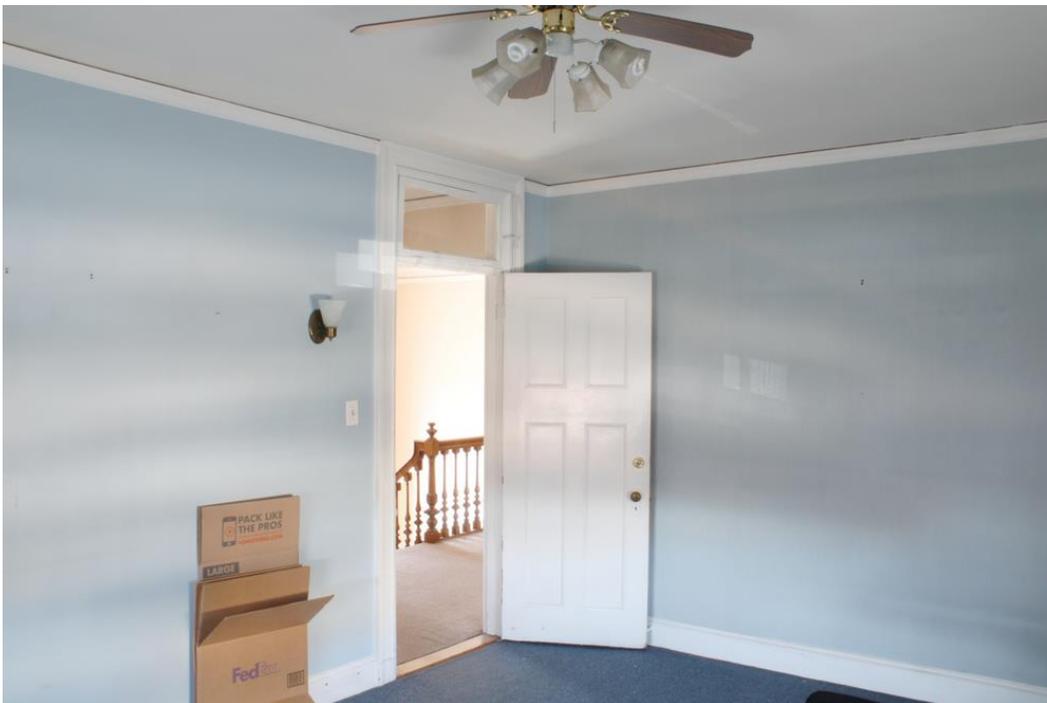
Image 21 Typical second floor room at southeast corner. Room retains original wood door and trim, transom, baseboard and cornice.

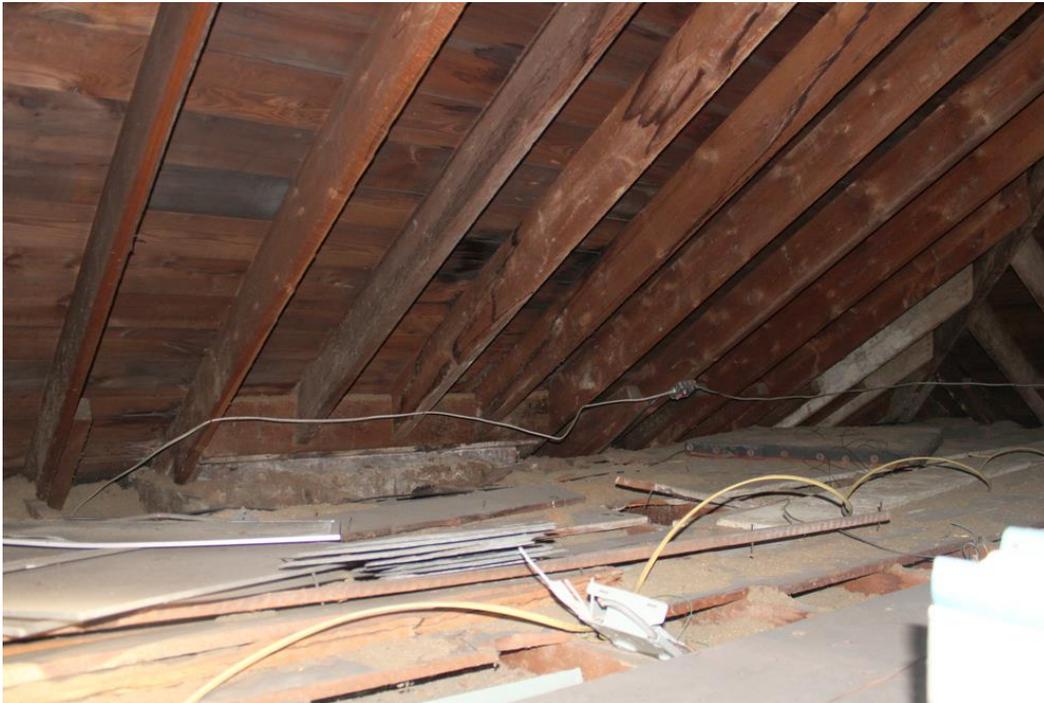
Image 22 View in attic, looking north. Small amount of masonry associated with chimney is just visible in center of image.

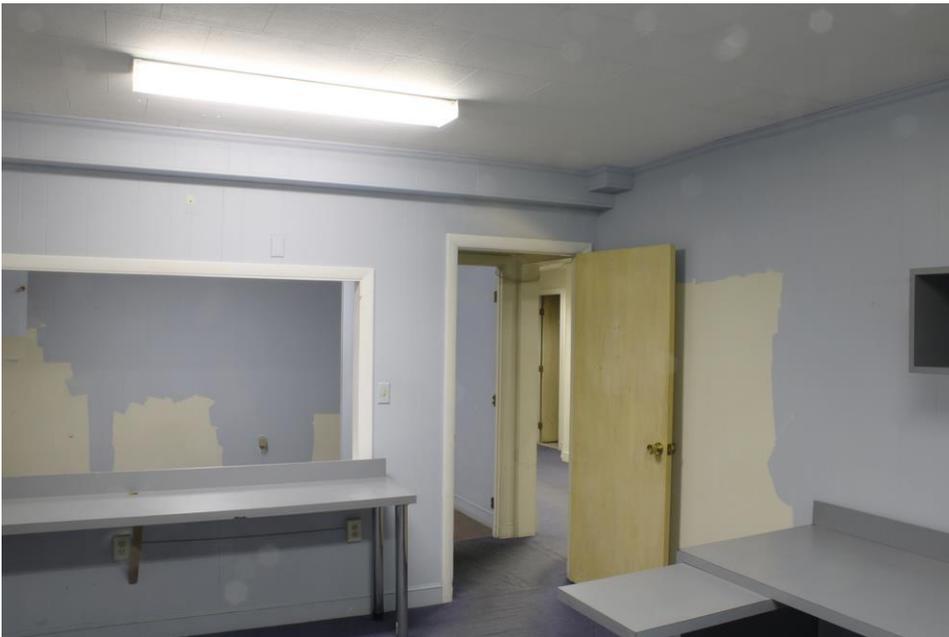
At the basement level, modern alterations include vinyl paneling and acoustical drop tile ceilings with fluorescent light fixtures. Through an access panel in the southeast basement room, it appears that the original basement had some degree of finish with a plaster wall and painted wood baseboard. Removed ceiling tiles indicate the ceiling of the basement space was also finished with plaster.

Image 24 Basement view showing typical finished conditions including late 20th century slab doors, wood trim, and vinyl wall paneling.

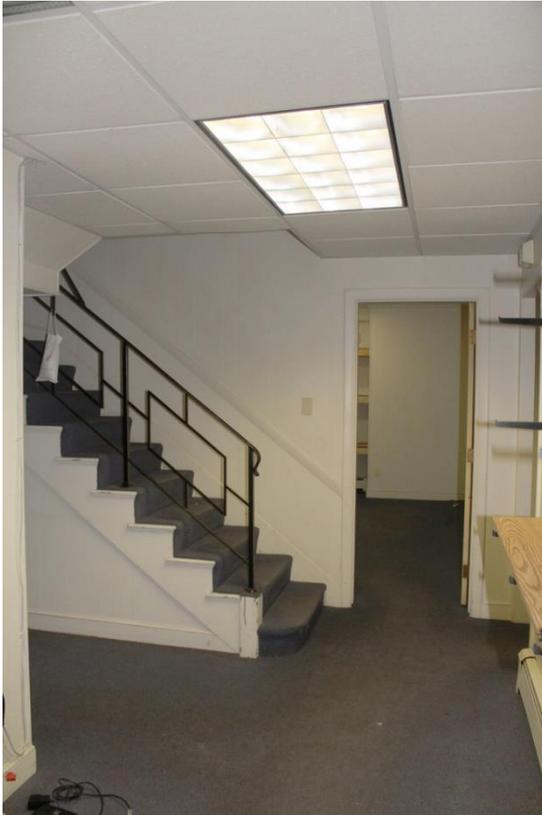
Image 25 View in basement corridor showing original stairway from first floor; looking north.

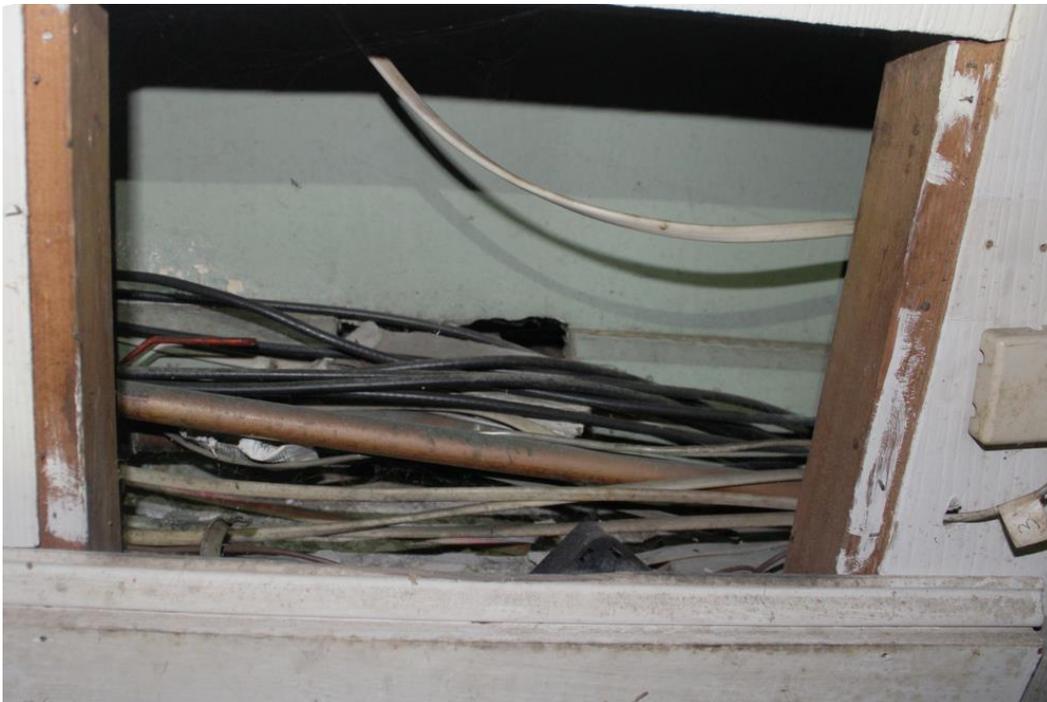
Image 26 View in wall opening showing original painted plaster wall and small section of wood baseboard trim. Details suggest an original level of finish to the basement space.
